ASBESTOS RE-INSPECTION SURVEY REPORT

WAREHOUSE 3
GSA BUILDING NUMBER WA0822KF
2507 C STREET SW
AUBURN, WASHINGTON

ASSESSMENT DATE:
09-13- 2012

GSA- WAREHOUSE 3
 BUILDING NUMBER - WA0822KF
 AUBURN, WASHINGTON
 HOMOGENEOUS MATERIAL DRAWING

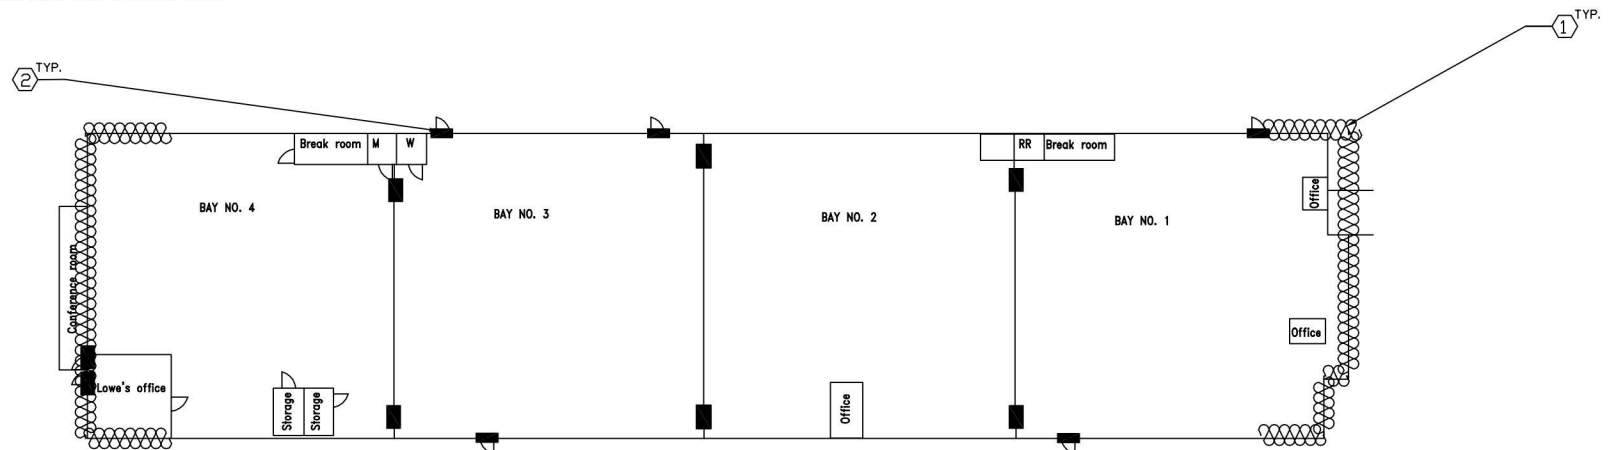
HM-1.0

- CEMENT ASBESTOS BOARD EXTERIOR SIDING AND ASBESTOS CONTAINING FELT VAPOR BARRIER PAPER
- ASBESTOS CONTAINING CORE FIRE DOORS. INTERNAL FIRE DOORS SEPARATE BAYS AND ARE APPROXIMATELY 10'X20' EACH.
